Your Inspection Report

123 Sample St
Colorado Springs, CO

INSPECTION DATE:
Thursday, October 30, 2014

RE: Report No. 1295
123 Sample St
Colorado Springs, CO

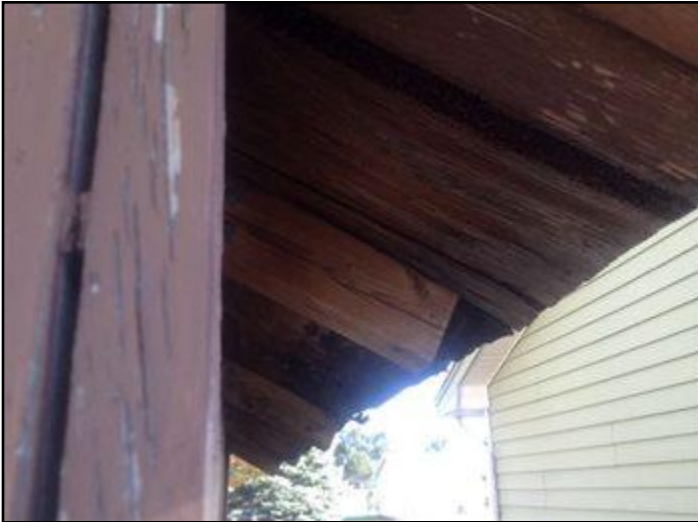
1. • Miscellaneous exterior findings - see below photos

Rot - shed soffit (due to no gutter)

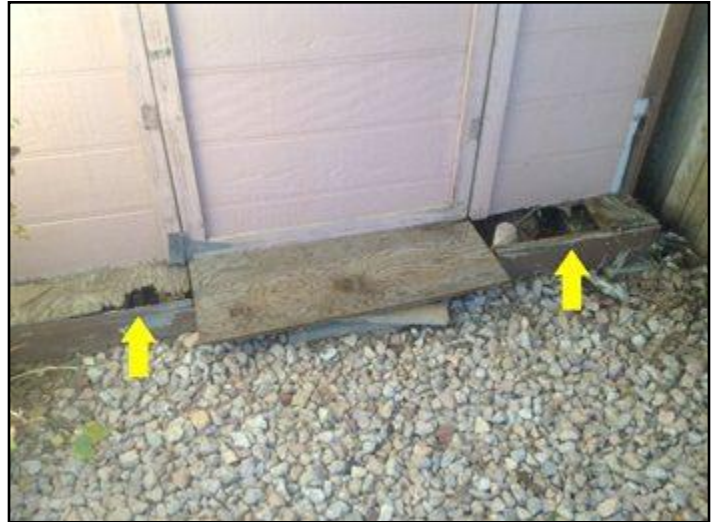
Rot

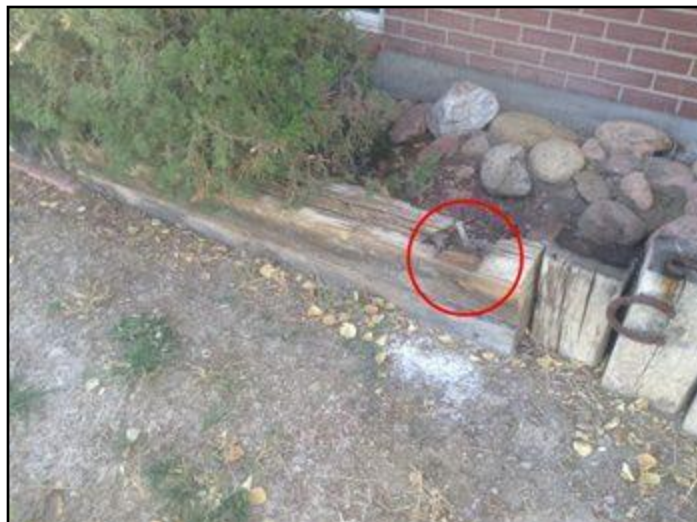
Rot

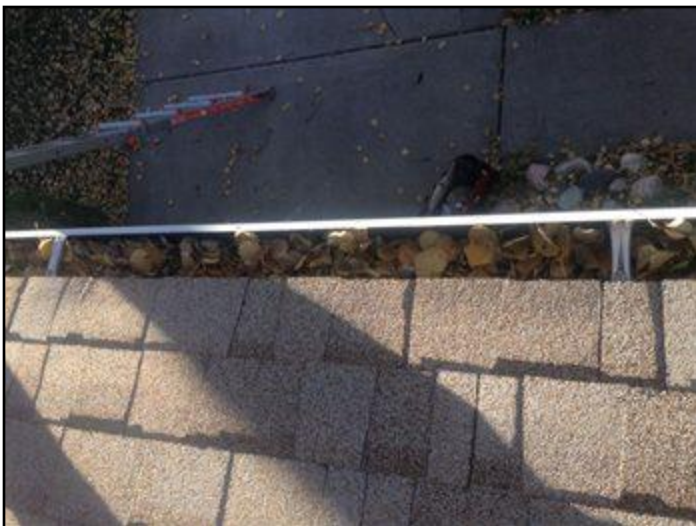
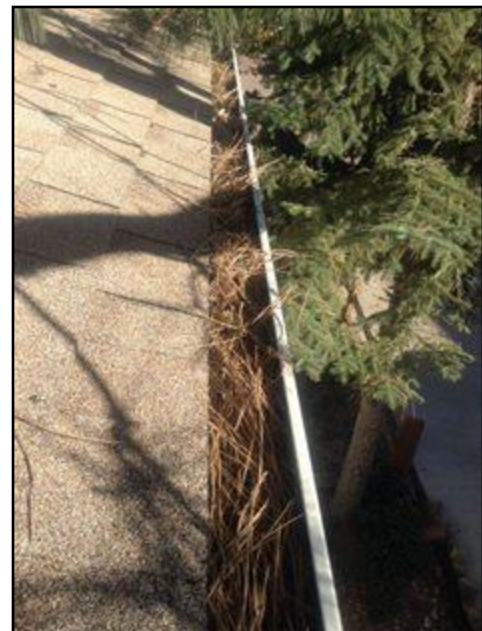
2. **Condition:** • [Clogged](#)

Implication(s): Chance of water damage to contents, finishes and/or structure

Clogged gutter

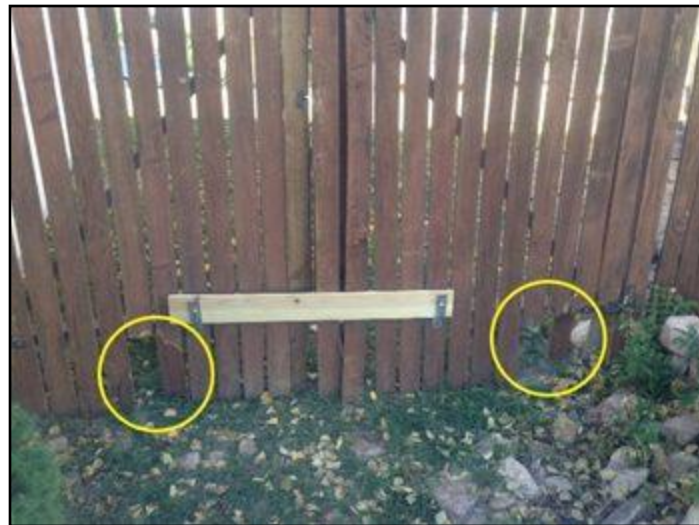
6. Condition: • Gap - pet could exit yard

Gap - pet could exit yard

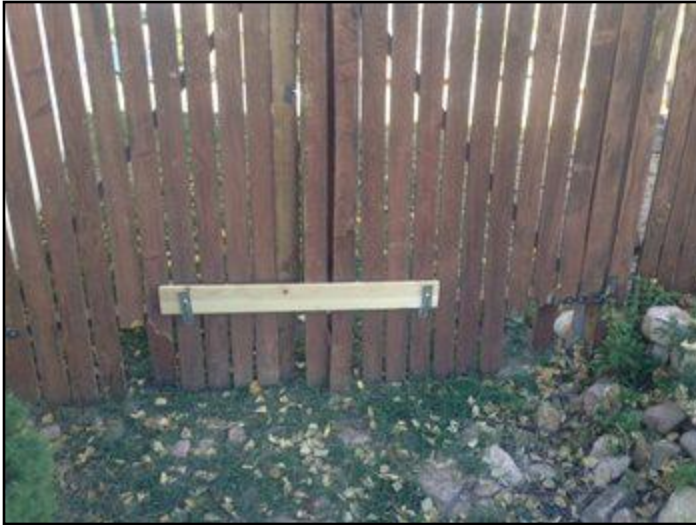
Damaged boards - NE

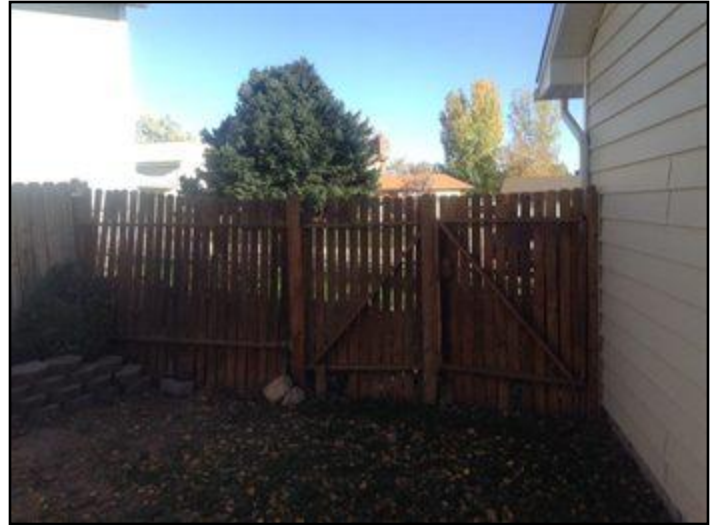
Unstable section - NE

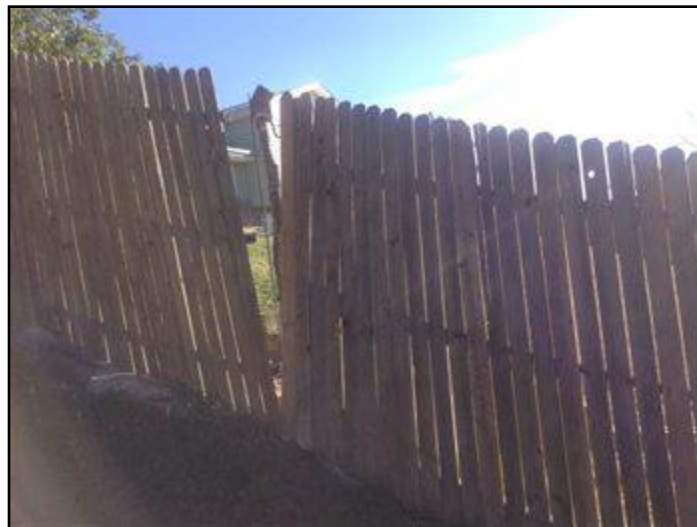
7. Condition: • Leaning

Implication(s): Chance of movement | Damage or physical injury due to falling materials

Leaning, detached section - south

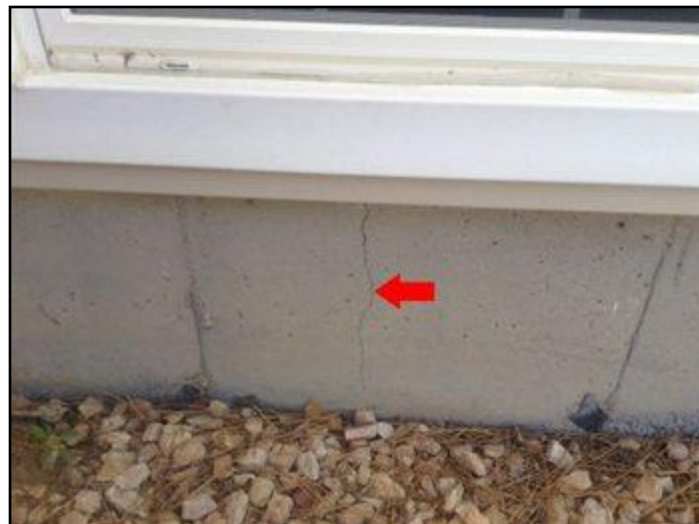
9. Condition: • Typical minor cracks

Minor hairline vertical crack. Monitor - if crack expands/worsens or water enters then repair will be required.

Typical minor crack

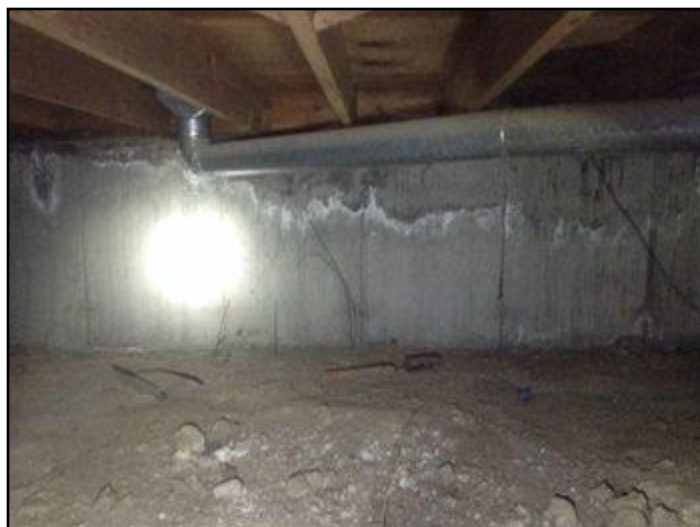
10. Condition: • [Efflorescence](#)

Efflorescence / water staining - foundation wall in crawl space - no action required unless moisture enters crawl space

Efflorescence

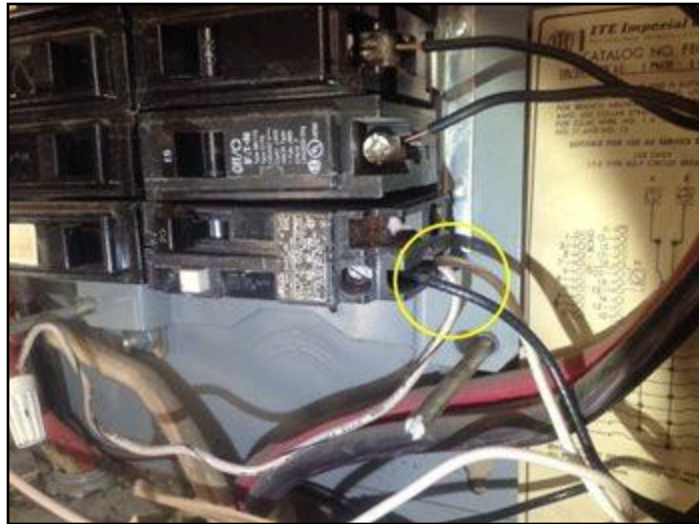
12. Condition: • [Double taps](#)

2 wires into 1 breaker. Recommend repair by licensed electrician professional. See Note 3 in Index of Notes.

Implication(s): Fire hazard

Double tap

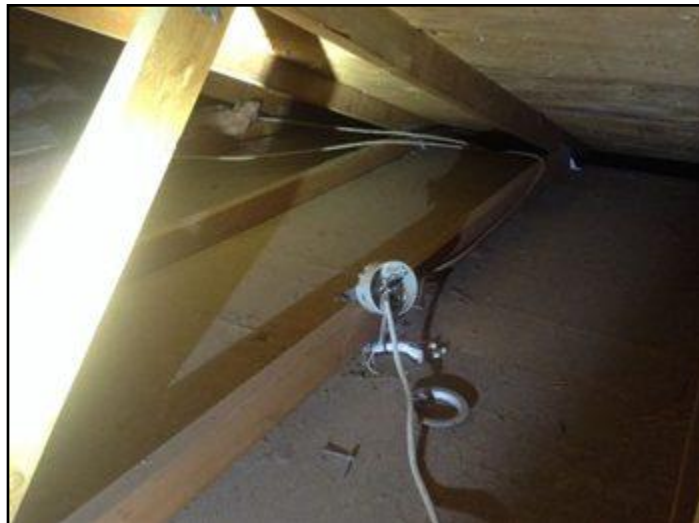
13. Condition: • [Exposed in attics](#)

Implication(s): Electric shock

Exposed in attic (Garage attic)

Recommend repair / junction box by licensed electrician

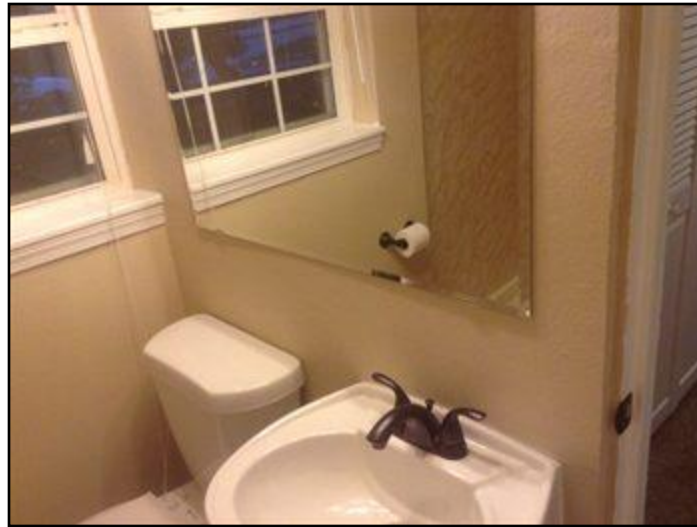
14. Condition: • No electric outlet in lower bathroom. Recommend installing GFCI outlet.

Missing outlet - lower bathroom

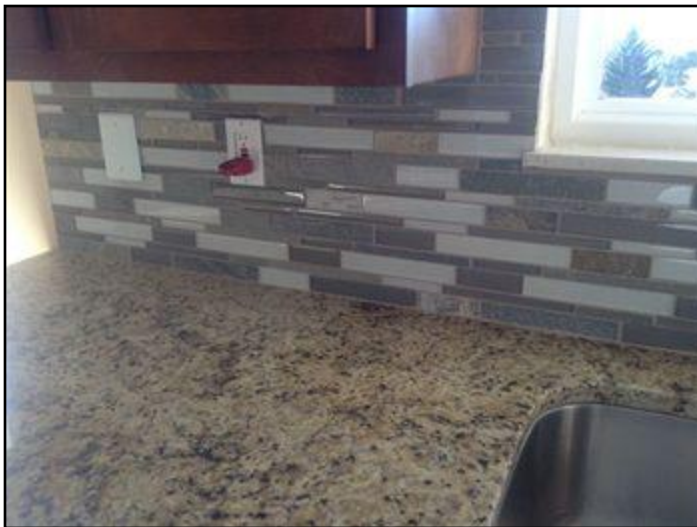
Inoperative outlets in kitchen, dining room + lower living room. I re-set all breakers in the panel but outlets still off-line. Recommend repair by electrician professional. See Note 3 in Index of Notes.

Inoperative outlet - kitchen

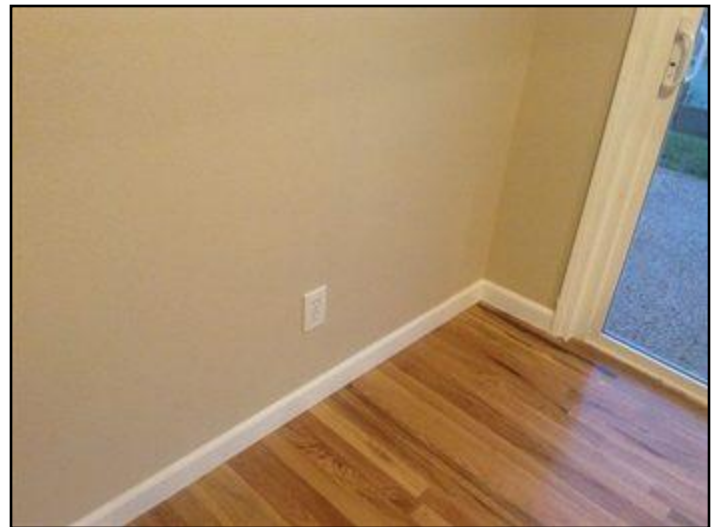
Inoperative outlet - dining room

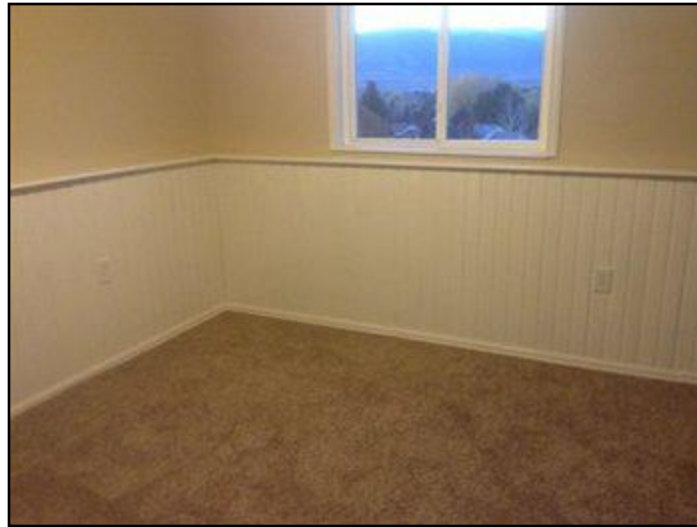
Inoperative outlets - lower living room

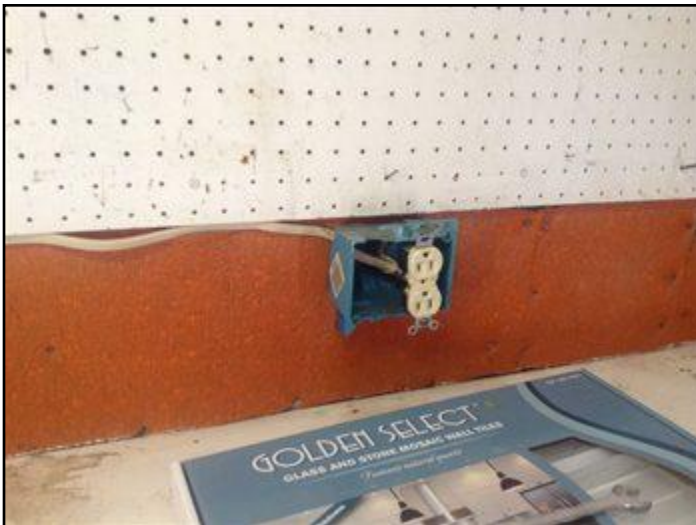
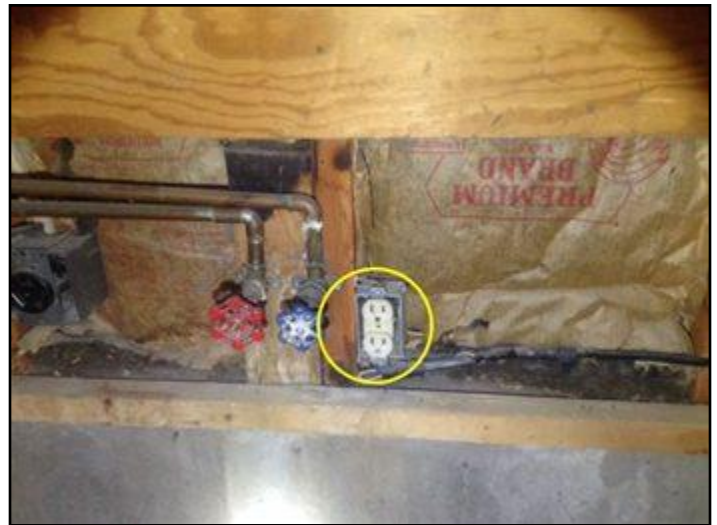
16. Condition: • [Missing](#)

Missing cover plate

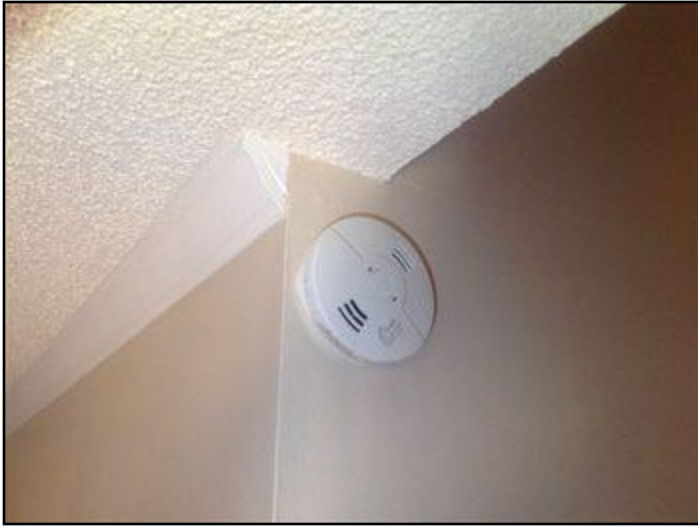
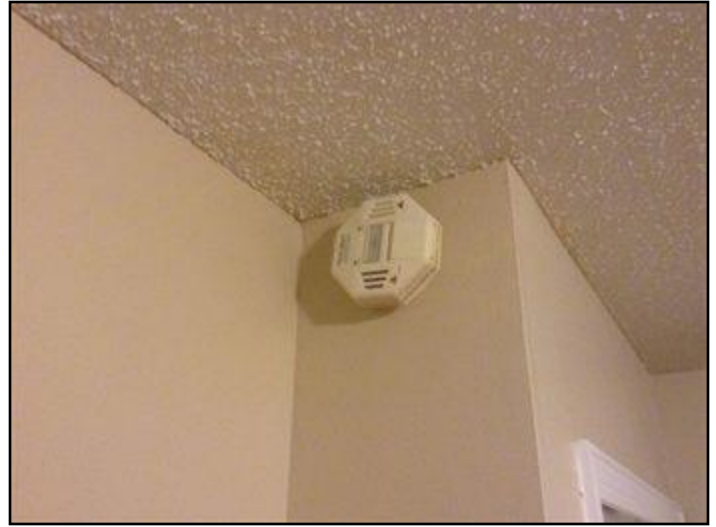
17. Condition: • [Inoperative](#)

Implication(s): Fire hazard

Inoperative

Install combo smoke + CO detectors to replace inoperative units

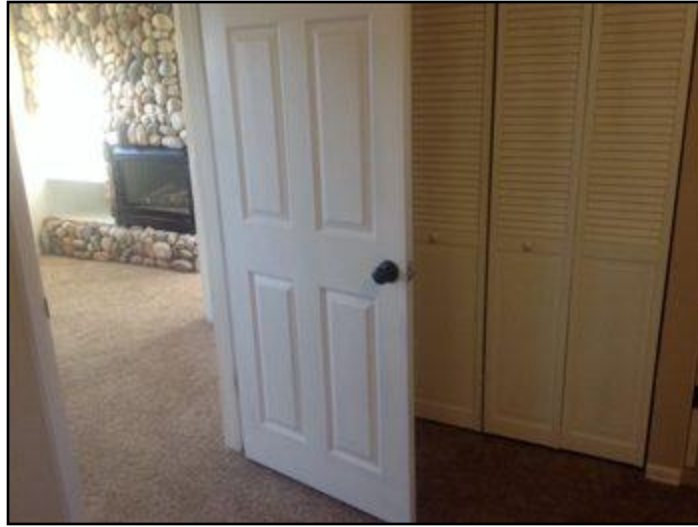
Add vent grill to door if used as bedroom

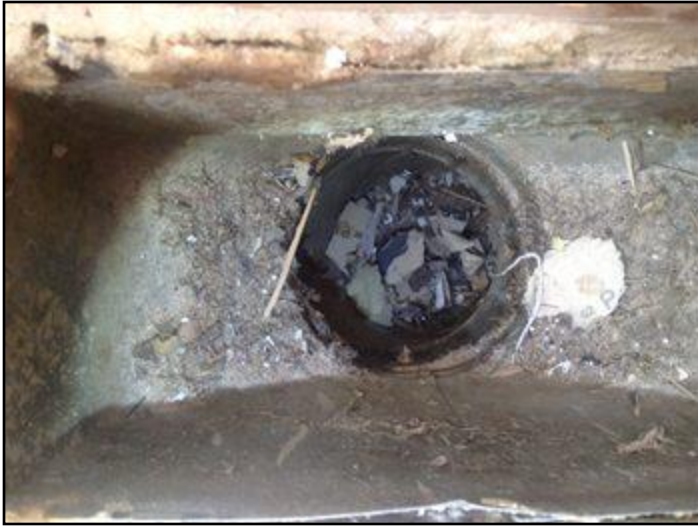
20. Condition: • Vacuum ducts/registers - dust, debris observed

Vacuum ducts/registers

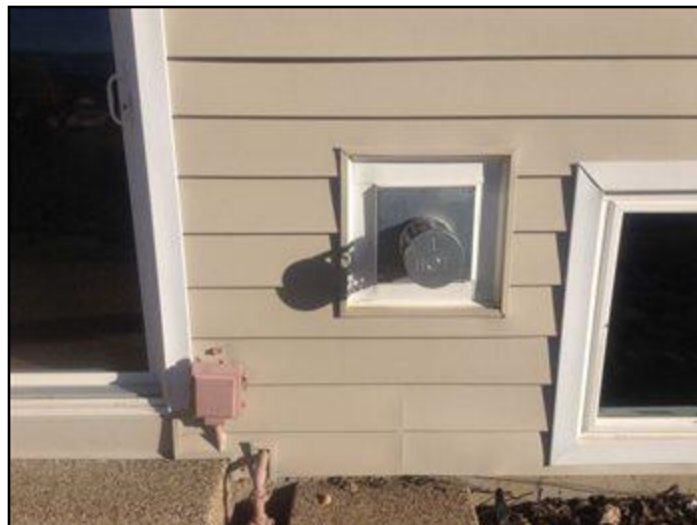
21. Condition: • Fireplace vent in high traffic area and approx 2'-3' from patio floor - safety hazard. The vent becomes very hot and a child or unsuspecting adult could be burned. Recommend encasing the vent in a protective, breathable grate for safety. See Note 1 in Index of Notes.

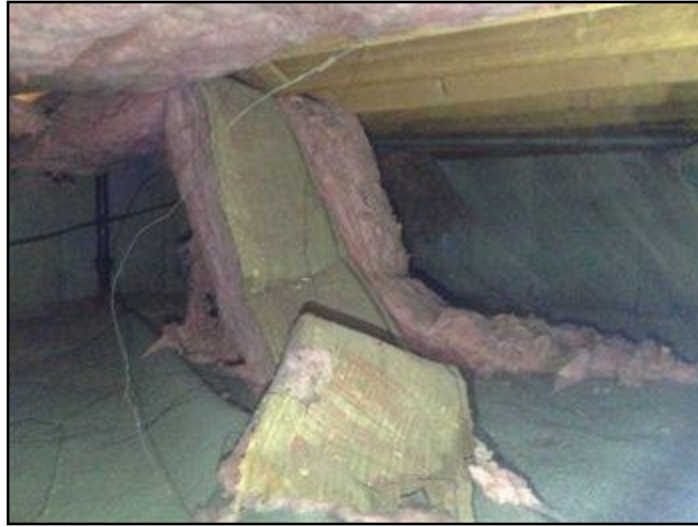
22. Condition: • [Gaps or voids](#)

Gaps or voids, fallen insulation

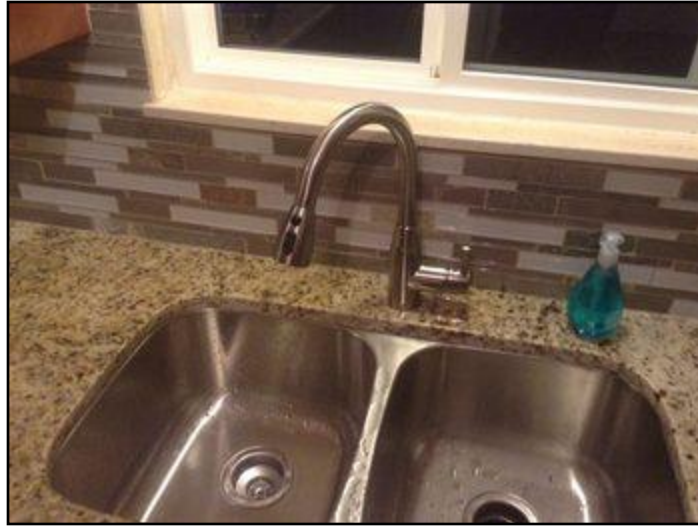
24. Condition: • No hot water - kitchen sink. I turned valve on & off below sink but no hot water supply. Recommend repair prior to occupancy.

No hot water - kitchen sink

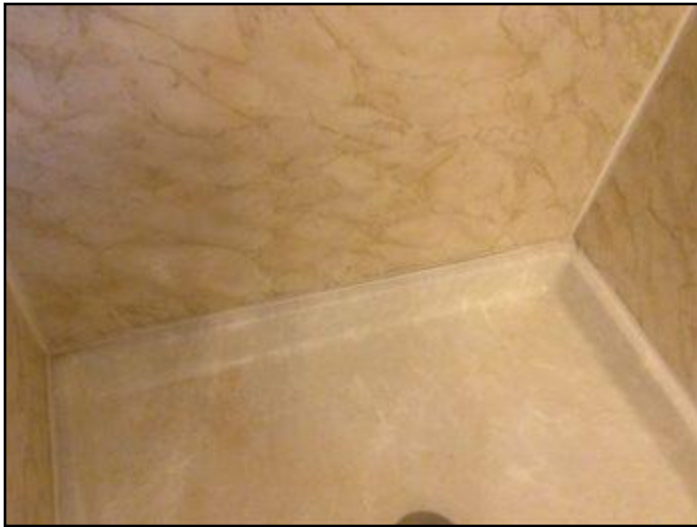
Caulk needed - lower shower

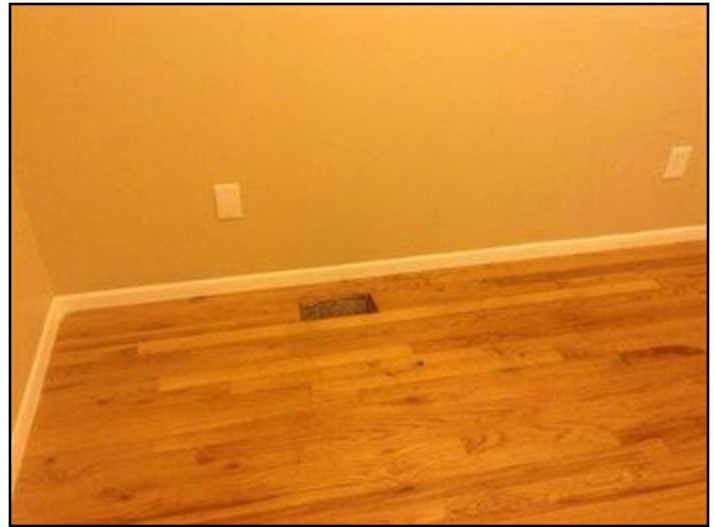
Missing register grill - west bedroom

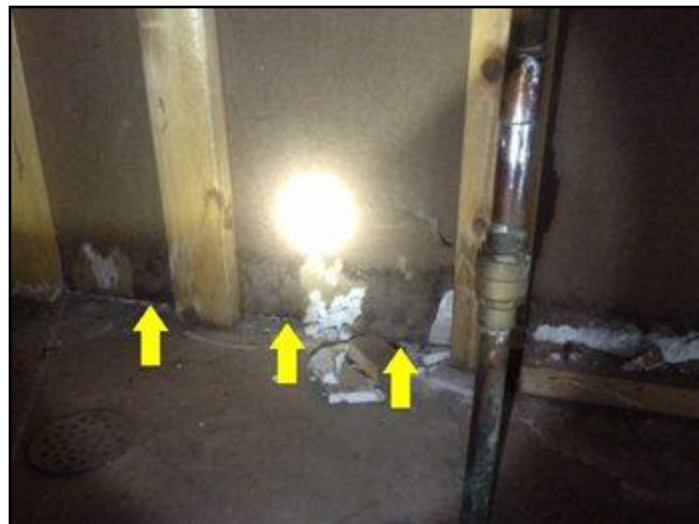
26. Condition: • [Water damage](#)

Water staining, possible mold/mildew at lower drywall behind lower bathroom (behind water heater). Clean/apply Kilz. If staining extends beyond the visible section, you will need to consult a mold abatement professional.

Water stains
