Your Inspection Report

123 Sample St
Colorado Springs, CO

INSPECTION DATE:
Thursday, October 30, 2014

RE: Report No. 1295
123 Sample St
Colorado Springs, CO

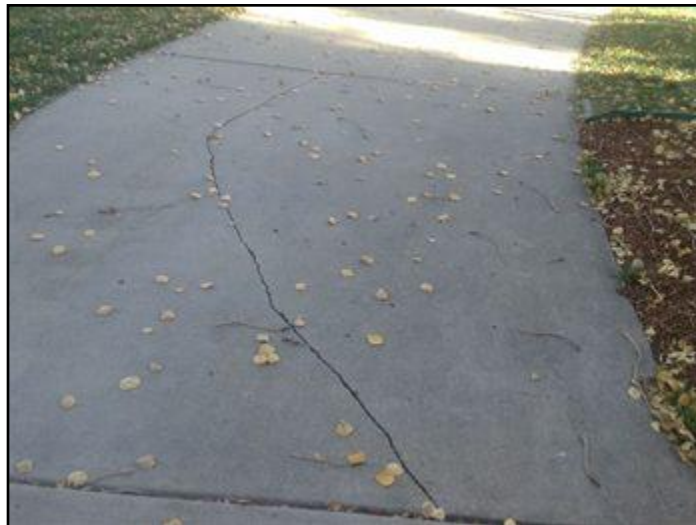
Typical minor cracks observed - caused by settling, frost heave or freeze/thaw expansion and contraction

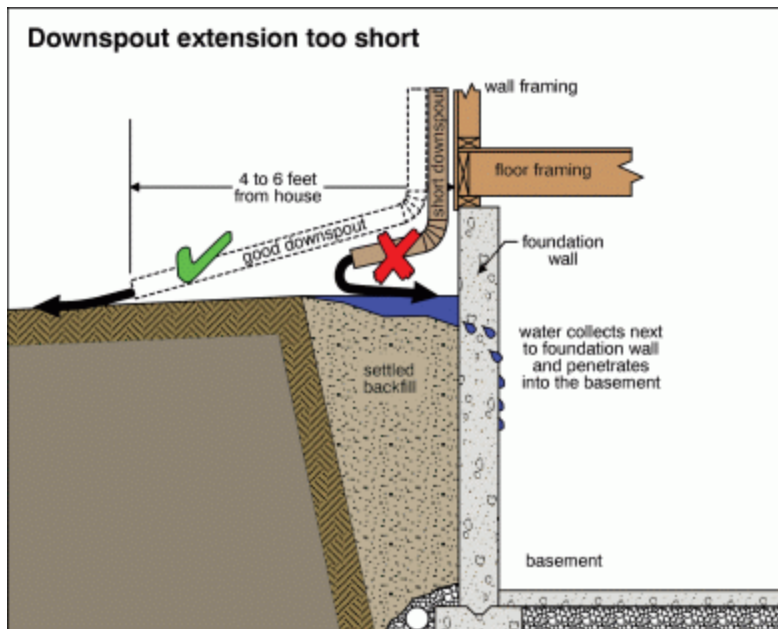
3. Condition: • [Downspouts end too close to building](#)

Downspout extension too short

Recommend adding extension to downspout in order to route water away from structure

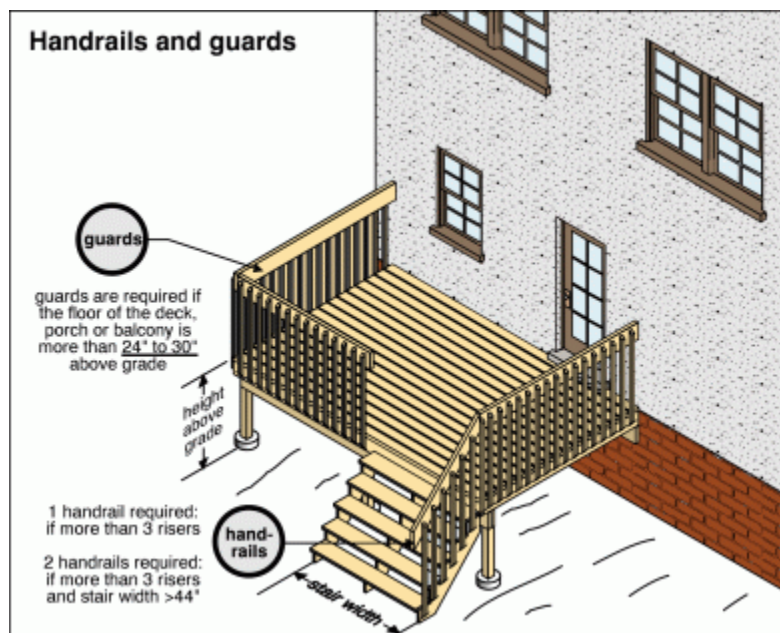
Safety hazard - west portion of rear Deck greater than 30" above grade

Implication(s): Fall hazard

Recommend installation of minimum 36" (max 42") guard rail for safety. Code states guard rail must be 36" height on decks/walkways greater than 30" above grade. Spindles/boards underneath the top rail must be 4" or less apart. See Notes 1 & 3 in Index of Notes.

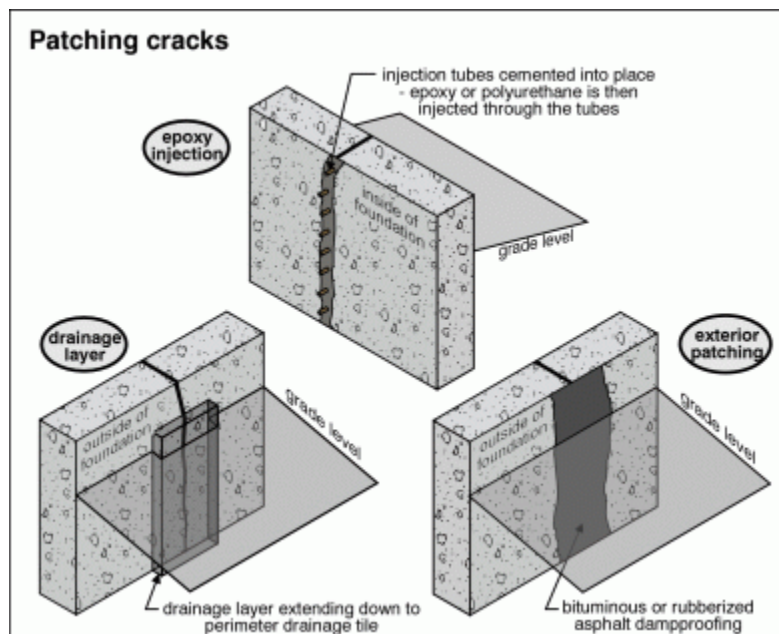
9. Condition: • Typical minor cracks

Minor hairline vertical crack. Monitor - if crack expands/worsens or water enters then repair will be required.

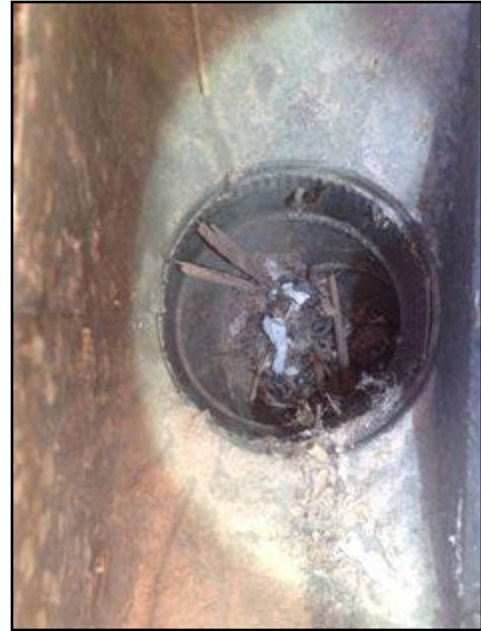
Condition: • Vacuum ducts/registers - dust, debris observed

Vacuum ducts/registers

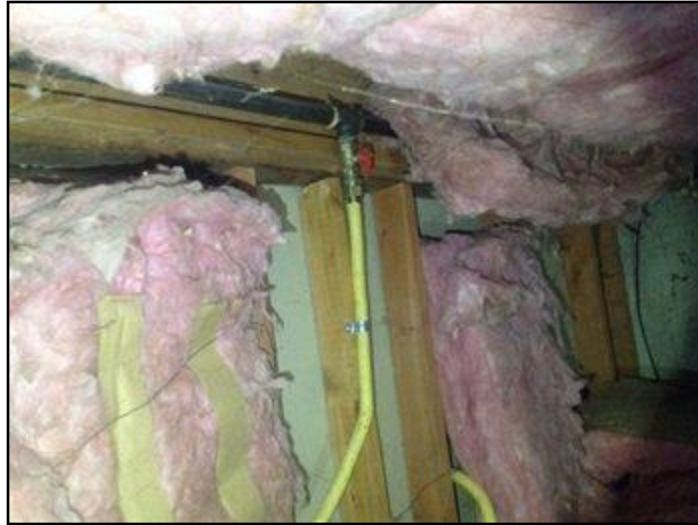
Plastic flex gas line

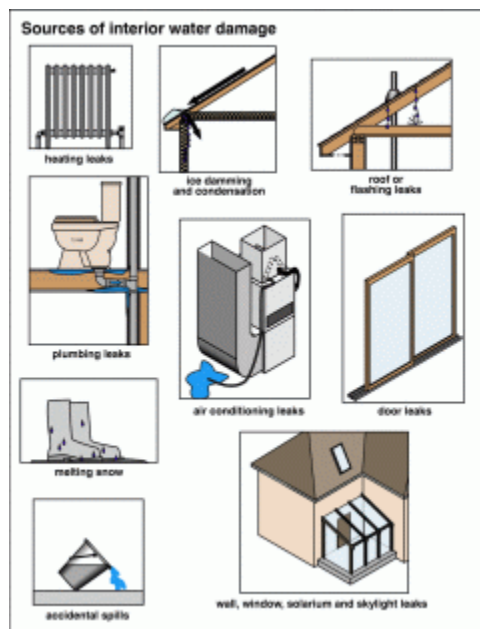
Location: Utility Room near main water shutoff

26. Condition: • [Water damage](#)

Water staining, possible mold/mildew at lower drywall behind lower bathroom (behind water heater). Clean/apply Kilz. If staining extends beyond the visible section, you will need to consult a mold abatement professional.

Implication(s): Cosmetic defects
